# Manhole Inspection Summary

Manhole # S55E\_\_014MH

Insp Date: **6/11/08 10:38 AM**

**Location** Address: **141 s eaton st**

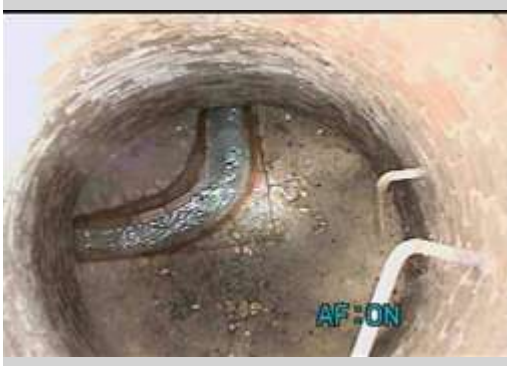
Defect 1

**Steps** Count: **2** Missing: **0** ☒ Corroded

steps

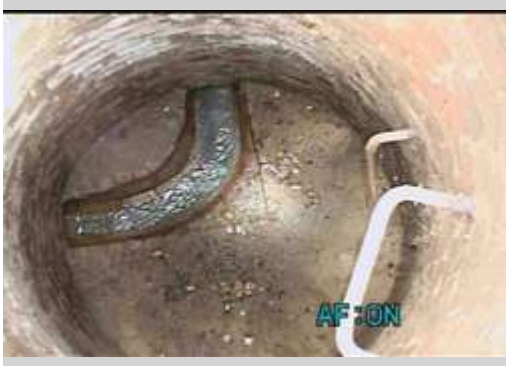
Defect 2

Condition: ☐ Sound ☐ Cracked ☐ Root Intrusion ☐ Deteriorated ☐ Leaks ☒ Debris

bench debris

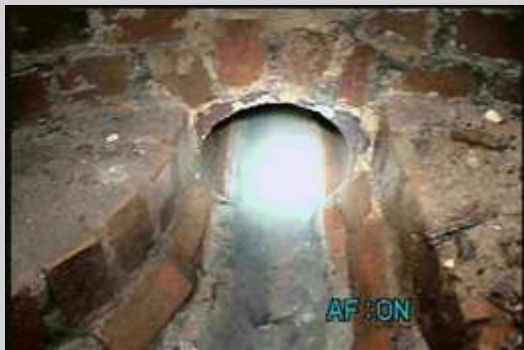
12 O'Clock Outflow

8 in. Circular Gravity Sewer  
Pipe Out @ 12 O'Clock

Pipe Material: **Clay** ☐ Pipe Lined

Invert Depth: **8.80** (ft.) Flow Characteristics: **Fast**

Deposits: ☒ None ☐ Mud ☐ Sludge ☐ Debris ☐ Grease

Infiltration: **None** Pipe Seal Cond: **Unknown**

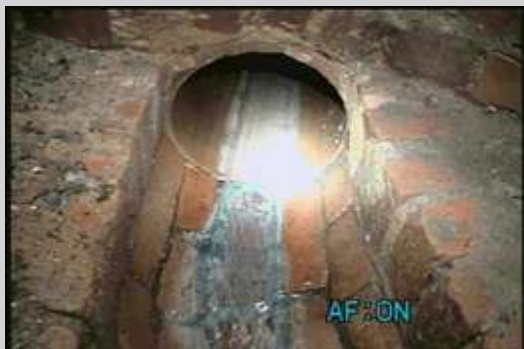
9 O'Clock Inflow

8 in. Circular Gravity Sewer  
Pipe In @ 9 O'Clock

Pipe Material: **Clay** ☐ Pipe Lined

Invert Depth: **8.60** (ft.) Flow Characteristics: **Fast**

Deposits: ☒ None ☐ Mud ☐ Sludge ☐ Debris ☐ Grease

Infiltration: **None** Pipe Seal Cond: **Unknown**
